Claw & Shuttle Management in Tobin Video Transfer TVT S8 R8 and D8 Telecine Models

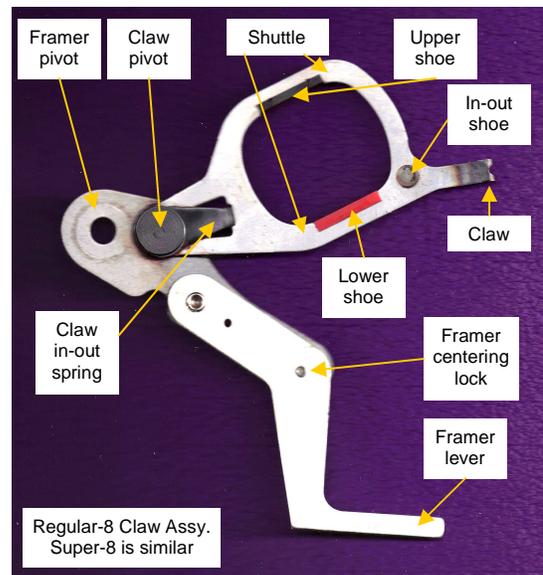
Top: new claw

Middle: worn but should still work

Bottom: excess wear, needs filing up to dotted line

nothing important will get crushed, and file it down with a fine-tooth flat jeweler's file. Keep the taper on the claw tooth the same as before and avoid making sharp edges. Do not apply too much pressure or the tooth will snap off. If the tooth is harder than usual you might have to use a diamond-coated file to cut it. If the tooth is soft, files easily, bends while filing and does not appear to have been hardened, this is a bad sign and additional filing, or replacement, should be anticipated before too long. In this case, now might be the time to think about ordering a parts projector.
